Analysis of the need for additional work concerning problem with the barrier system

Associate Professor Olle Grinder, PM Technology AB,

May 2012

Comments on SKB's application for final disposal of nuclear waste and the associated safety assessment SR-Site.

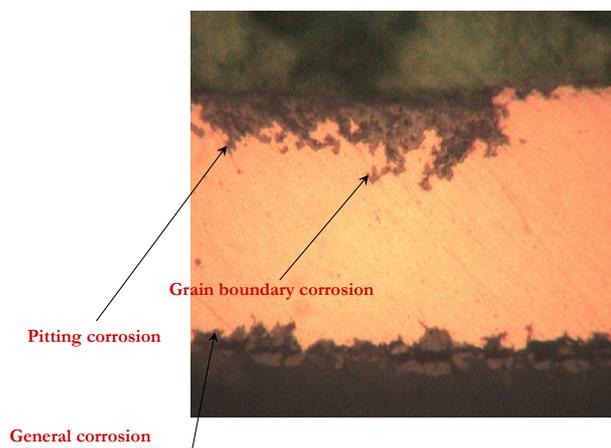
Figure 1. G. Hultquist, (2009).

It is common practice at corrosion testing of metals to determine the occurrence of corrosion attacks and corrosion products by means of metallographic examinations. Figure 1 shows the different corrosion attacks on a copper sheet, which was exposed to distilled and oxygen-free water for 15 years (Hultquist, 2009). The copper sheet was cut, ground, polished and then subsequently studied in metal microscope. It appears from the photograph that the copper was subjected to general corrosion, pitting and grain boundary corrosion. It is also common to examine corroded surfaces in light optical microscope and SEM (scanning electron microscope).

Cross-section of 0.1 mm copper foil

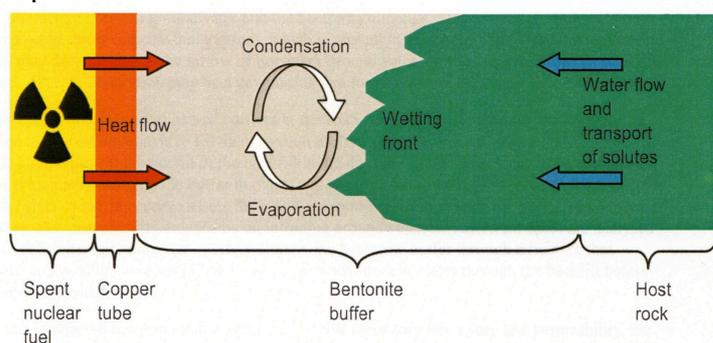
Figure 2. Sena et al, SKB TR-10-59, page 13.

Sena et al have presented a model for the flow of water from the granite wall of the deposition holes towards the canisters during the initial period, when the water saturation of the bentonite takes place; see Figure 2 below (SKB TR-10-59, page 13). Remarkably, the model does not consider that there is an air gap between the copper canister and bentonite.

According to the model water evaporates at the water front and water vapour diffuses through a bentonite zone towards the hot canister that is in the opposite of the heat flow. It is likely that mass transport is opposite to that described in the figure and that the water vapour diffuses to the waterfront, and then condenses. The effect of these reactions is that the salts dissolved in the water are transported towards the canisters and is precipitated in the bentonite, when the water is evaporated.

Figure 2-1. Sketch of a vertical cross section of the near-field of a KBS-3 repository showing the thermo-hydraulic and transport processes that are believed to occur during the saturation period of the bentonite buffer.

There will thus be evaporation and condensation of water vapour in a zone in the bentonite. Some of the water vapour will escape into the air gap between the canister and the bentonite and through cracks in the bentonite (see Figure 3 below from Atkins, 2009, SKB R-09-29) into the deposition tunnels above the deposition holes. SKB have introduced a completely unrealistic assumption that has not been verified experimentally, that all the deposition holes are hermetically sealed in the 100 to 1000's year period that it takes to water saturate the bentonite in the tunnels and deposition holes.

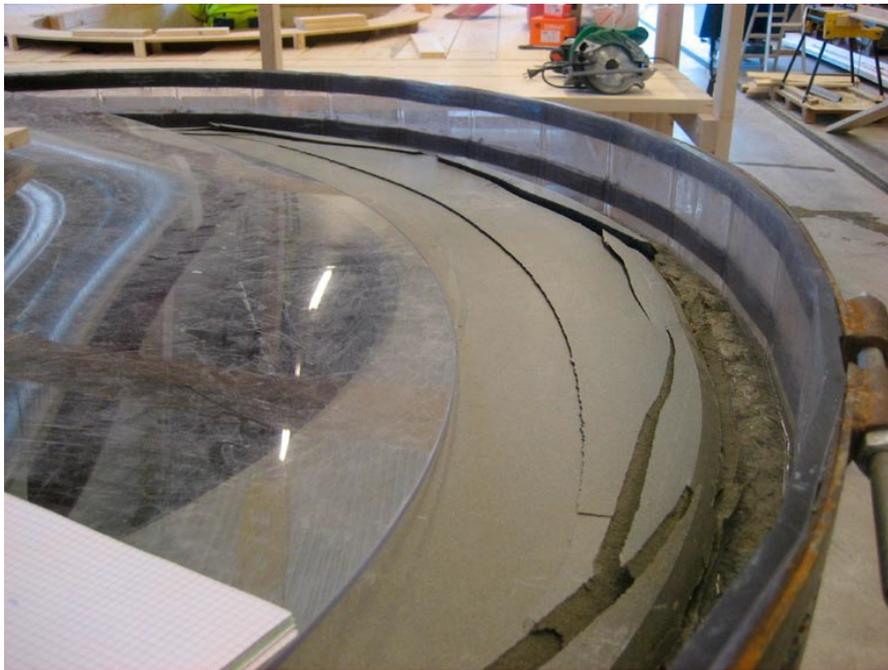
Figure 3. Large cracks in the ring after 48 h (Åberg 2009, SKB R-09-29).

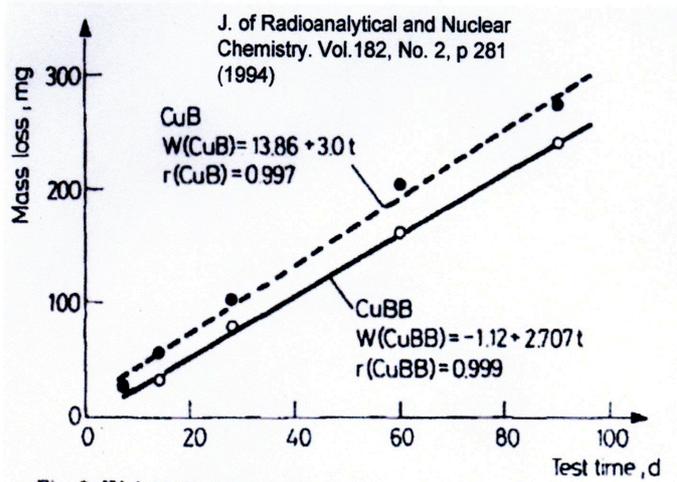
Fig. 3. Weight discrepancies of Cu

Evaporation of the water that flows into the deposition holes leads directly also to an enrichment of dissolved salts in the water found in the deposition holes with chloride, sulphide or sulphate ions. Even if only a very limited portion of the incoming water evaporates and leaves the deposition holes, this leads to an increase in salinity of the water. Elevated contents of chloride ions in water are known to strongly corroded copper see Figure 4 below.

Corrosion of copper (>99.99%) at oxygen free exposure in autoclave in brine with 14% Cl⁻ at 90°C. Linear corrosion rate about 100 μm/year.

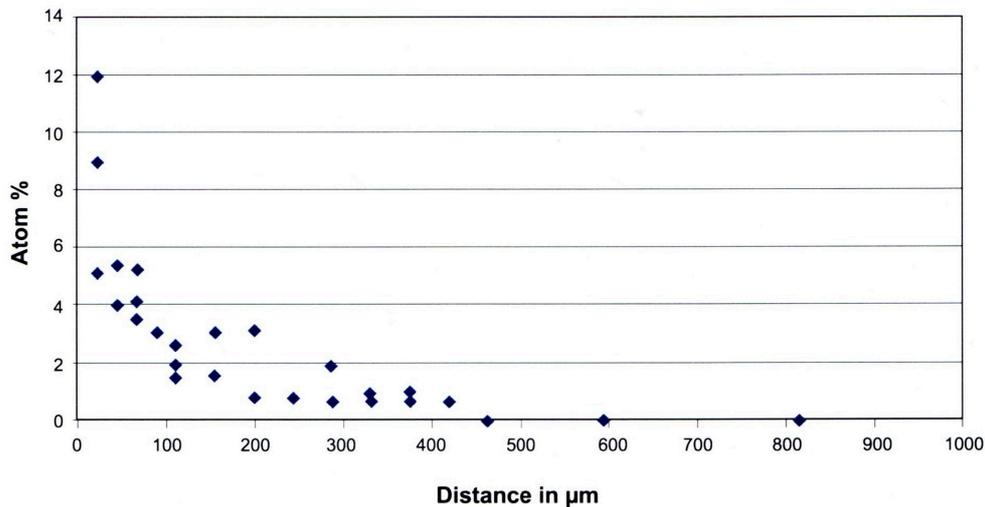
Both Karnland et al and Rosborg must be well aware of the fact that this information is wrong and misleading. It is evident from the report SKB TR-09-29 that copper dissolves in the water and copper ions diffuse into the bentonite where the copper is precipitated, in part as copper sulphide. Elevated copper levels were measured in the bentonite at a distance of up to 20 mm from the copper pipe. Rosborg observed also that the copper, from the samples, had penetrated the bentonite to a depth of 500 microns perpendicularly from the copper surface. Rosborg also determined the content of copper in the bentonite as a function of the distance from the copper surface, see Figure 5.

Figure A3-3. Copper profile in bentonite next to copper coupon A230H.

Figure 5. Karnland et al (SKB TR-09-29), precipitation of copper in the bentonite.

An estimate based on the copper concentrations in the bentonite; see Figure 6 below gives an actual corrosion rate of 10 - 20 microns/year. It must be obvious even to Karnland et al and Rosborg that the corrosion rate must be much greater than 0.5 microns/year when such high levels of copper are found in the bentonite as shown in Figure 5. See further below under section 3.7.

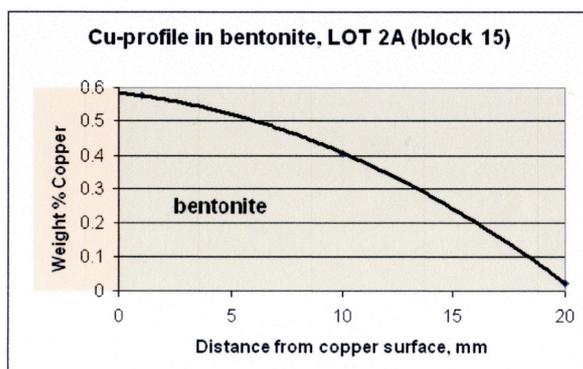
Figure 6. Szakalos P. (2009)

SKB have found, in several corrosion experiments with copper samples placed in water-saturated bentonite, high levels of copper in the bentonite in a zone of a few centimetres from the copper surface. These results were obtained after a few years of exposure of the copper. The amount of copper precipitated in the bentonite can be converted to a corrosion rate of 10 - 20 microns/year over a 6 year period in the LOT 2 trials, which is a very high corrosion rate, see Figure 6. This corrosion mechanism have been considered only to a limited degree of SKB and are not included, for example in the compilation of corrosion mechanisms that affect the life time of the copper canisters (SKB TR-10-66 page 45 and Figure 6-1, Hedin, SKB TR-10-46, SR-Site, Part II, page 428, Figure 10-88 and SKB TR-11-01).

Äspö, Lot A2, BGR-studien

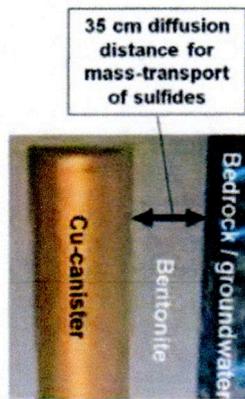
Figure 7 shows that copper dissolves in the ground water, after which the copper ions diffuse into the surrounding bentonite and finally become dispersed in the bentonite. Chemical analysis of the bentonite showed high levels of copper in the bentonite zone closest to the copper. The thickness of this zone was a few centimetres. Corresponding results of copper precipitates in the bentonite have probably also been found in prototype repository trials. SKB ought to theoretically and experimentally study how this corrosion mechanism influences the life of the copper canisters. The results SKB hitherto have published show that the bentonite accelerates the dissolution of copper and that the precipitation of copper in the bentonite may affect its functional properties.

The KBS-3 model:

All relevant copper corrosion processes are calculated by diffusion through a buffer in an "ideal state", water saturated and pressurised

Reality:

- Copper dissolution as Cu^{2+} och CuCl_2^-
- The bentonite surface acts as a sink for these ions. Different crystalline corrosion products precipitate on the bentonite
- The chloride ions get released and the corrosion process continues
- The bentonite and copper barriers break down each other and the corrosion continues with short diffusion distances

Figure 7. Presented material on the SSM conference in Rånäs, May 2012 /Szakalos P and Seetharaman S. 2012/.

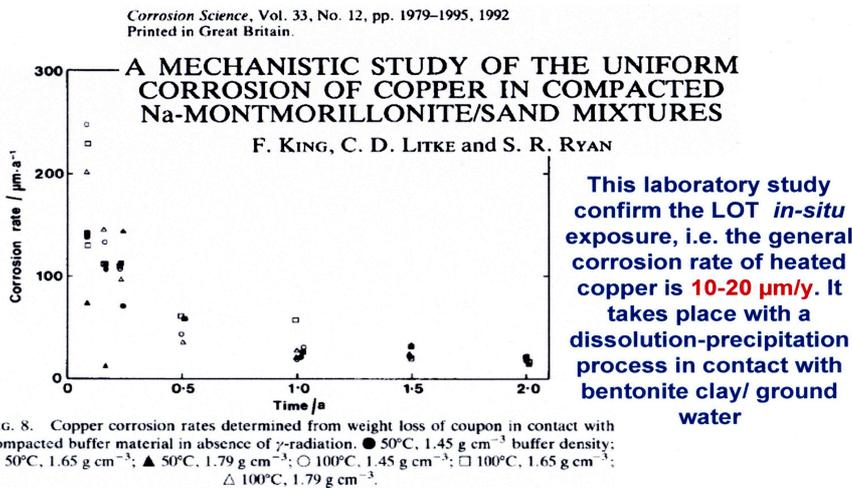
Figure 8. Szakalos P. (2009)

Similar results have also been published by King et al (1992). See Figure 8. Corrosion rates were measured in this study of approximately 20 microns/year after 2 years of exposure. It is surprising that SKB is not taking this corrosion mechanism in consideration in the safety analysis.

On page 1991, it was concluded that " O_2 -transport was not rate-limiting" and that the corrosion took place with a dissolution-precipitation process; "Precipitation of copper inevitably occurred in all of the tests, with usually more than half of the total copper corroded being in the form of precipitate rather than being sorbed on the clay".

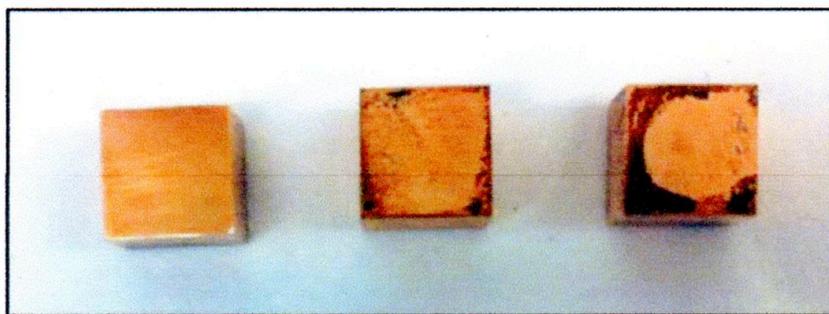
Figure 9. Björkbacka et al (2012)

This assessment should be compared with experimental results from a recent survey of Björkbacka et al (2012) see the photographs below, Figure 9. The report and photographs show that "gamma radiation causes significant corrosion of metallic copper in anoxic aqueous solution". Furthermore, it was found that the radiation resulted in a significantly higher content of copper dissolved in the aqueous solution compared with the reference sample. The radiation dosage used by Björkbacka et al were in the same range amounting from 10 to 100 Gy/h as in the earlier experiments carried out by King et al.

Figure 1. Photography of an experimental set of copper cubes. The cube to the left in the photography is the non-irradiated reference sample. The cube in the middle has received a total dose of 62 kGy while the cube to the right has received a total dose of 129 kGy. The irradiated copper cubes are more corroded than their reference sample.

This shows that SKB's and King's assessment of the significance of this corrosion mechanism is most probably wrong. There is a need for much more experimental results on corrosion of copper due to radiation, i.e. radiolysis of water. Gaseous copper corrosion must also be studied by the wet gas mixture (water vapour, nitrogen, etc.) during the initial period of a few thousands years before the bentonite is water saturated.

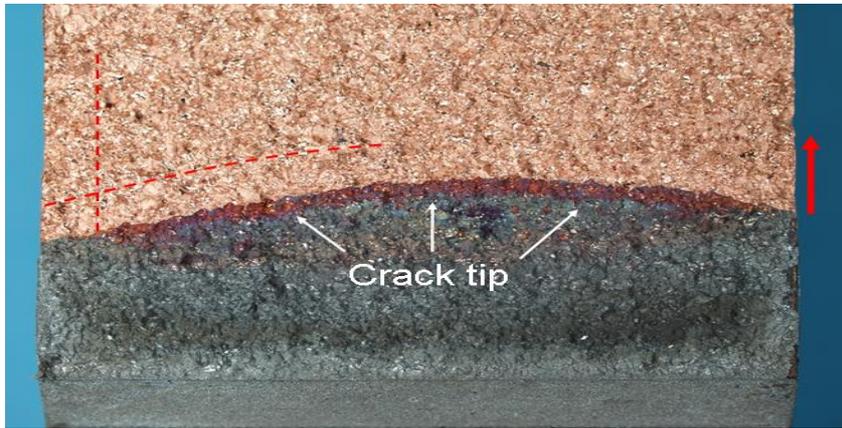
Figure 10. Arilahti et al. 2010

The results Ari-Lahti et al. reports are brand new, very important and describe a new embrittlement mechanism for copper that is sulphur embrittlement, see Figure 10.

Surface of Cu OFP specimen after a three week exposure to groundwater with 100 mg/l sulphide. The dashed red lines indicate lines along which local area SEM/EDS analyses were made with roughly one millimetre distance.

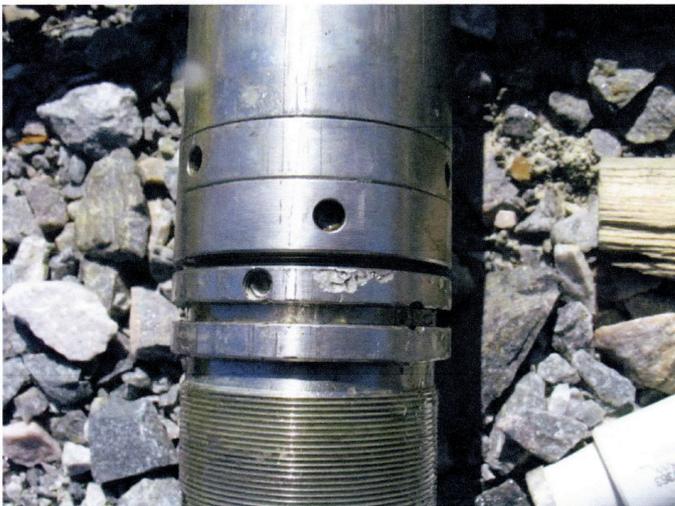
Figure 2-3. Pitting corrosion on the outside of the chemical analysing equipment.

Figure 11. Pitting of stainless steel SS2343 after 10 days of exposure in a borehole. Forsmark. SKB report P-05-265.

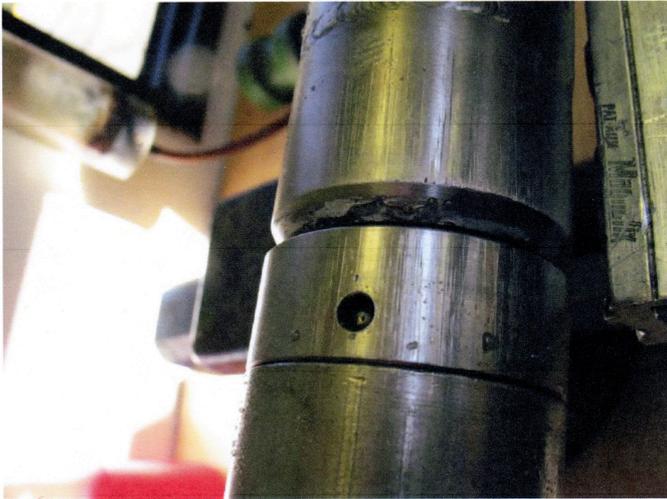
Figure 2-9. Details with crevice corrosion inside the chemical analysing equipment.

Figure 12. Crevice corrosion of stainless steel SS2343 after 10 days of exposure in a borehole. Forsmark . SKB report P-05-265.
